THE
COLUMBARIUM
RESTORATION PROJECT
Keeping History Alive

After a series of smaller and successful preservation projects at the cemetery, Friends of BNC turned its attention to the long-term task of restoring BNC's historic columbarium building which has been in continuous use for over 100 years. First came rebuilding and repairing areas of the building's complex roof.

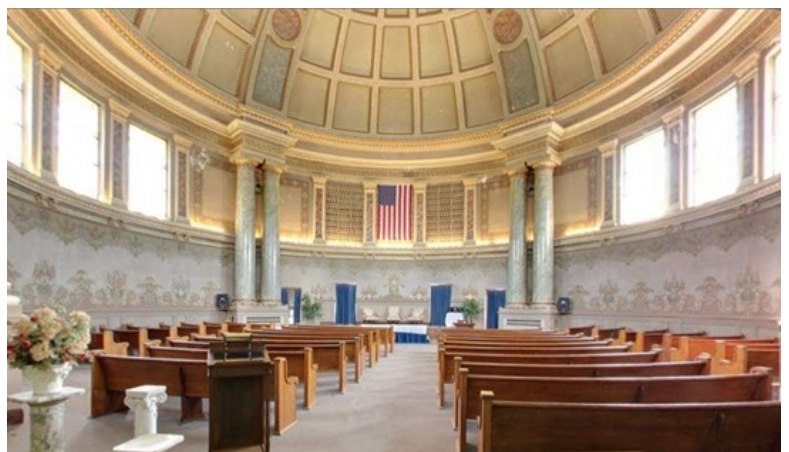
Friends then began raising money to restore the interior of the building's Ceremony Hall. Funded in part by a grant from the National Trust for Historic Preservation, this work focused on large sections of ornate wall paintings done by John Anton Mallin, a well-known artist and church decorator.

views of restoration work on the decorative wall painting in the Ceremony Hall

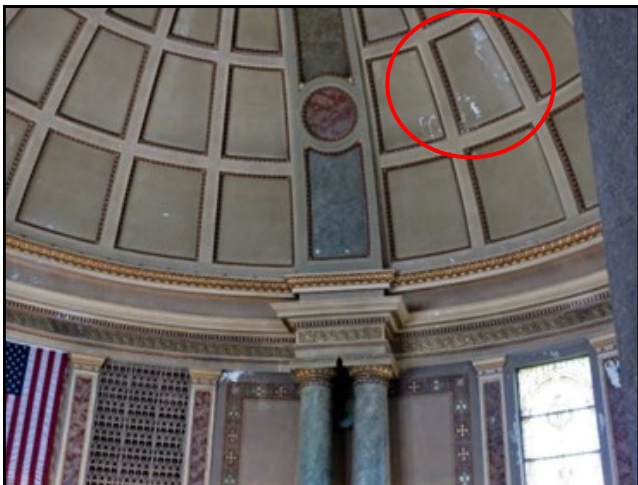
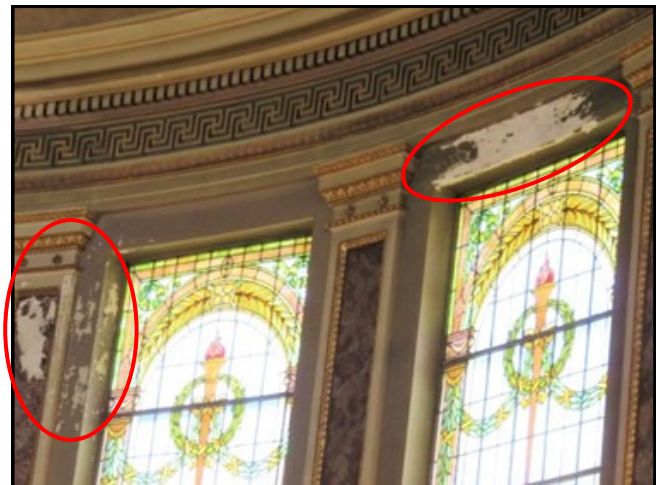
During the work, it became apparent that water infiltration was an on-going problem, likely getting into the building through both the roof and the walls. Restoration of the decorative painting was suspended and preservation professionals were hired to assess the building exterior's overall condition and to identify likely water entry points.

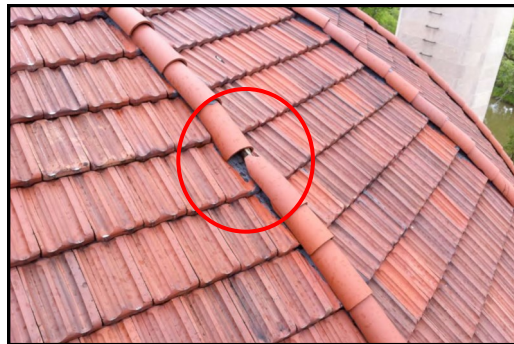
damaged tile on dome roof

Weatherproofing began at the top of the building. More than \$114,000 was raised to repair the dome roof and replace its deteriorating copper gutter system.

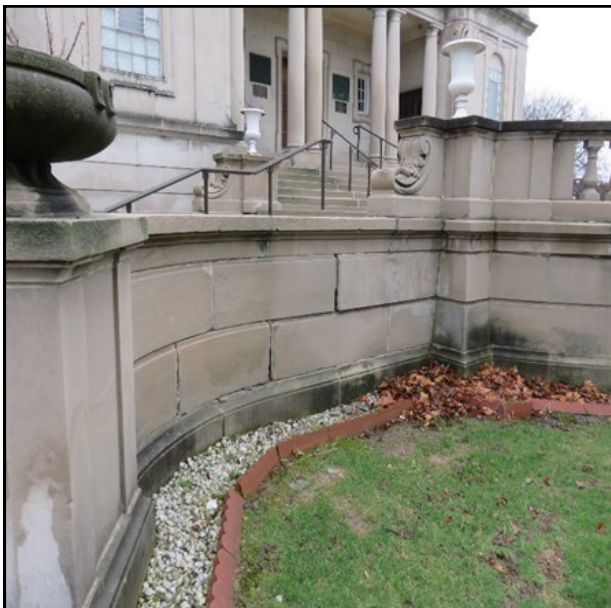
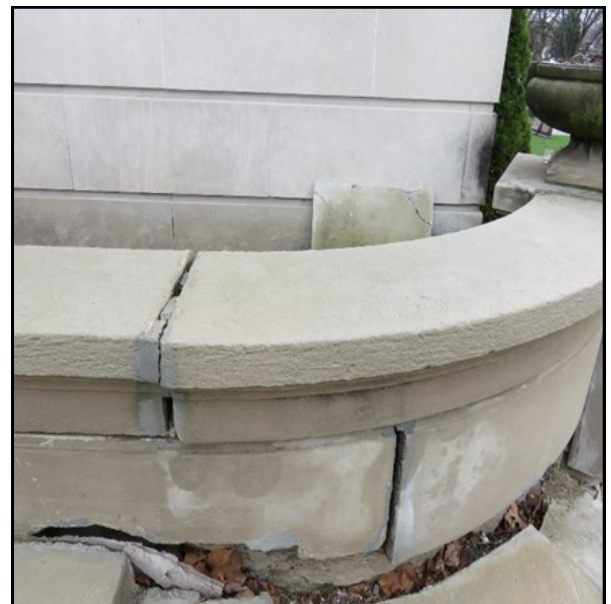
While the low limestone walls abutting the terrace and stairs are unsightly and need to be rebuilt, their condition presents no danger and does not compromise the building's integrity. As such, Friends will follow the recommendation of building preservation experts and not work on this area until other critical repairs are completed in order to secure the building against water infiltration.

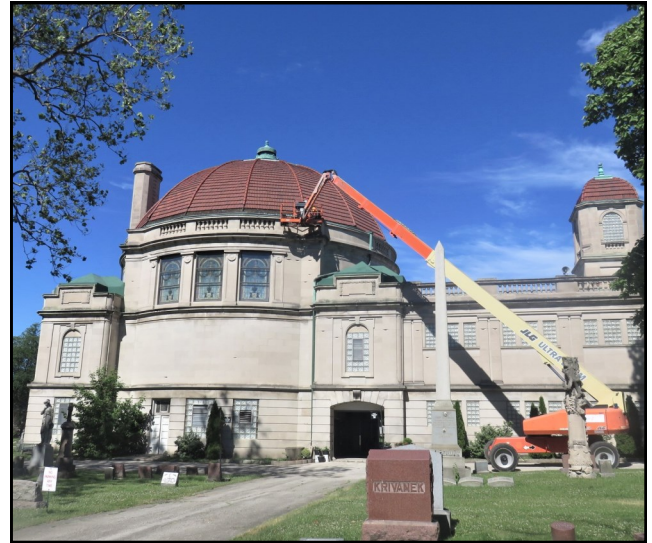
Several roofing contractors familiar with historic buildings were contacted and Friends of BNC submitted a recommendation to the Bohemian National Cemetery Association's Board of Directors that Knickerbocker Roofing Co. be selected to do the work. During the summer of 2017, Knickerbocker Roofing initiated and completed repairs to the dome including replacement of the copper gutter system surrounding the dome and resurfacing and repairs to the cupola at the top of the dome.

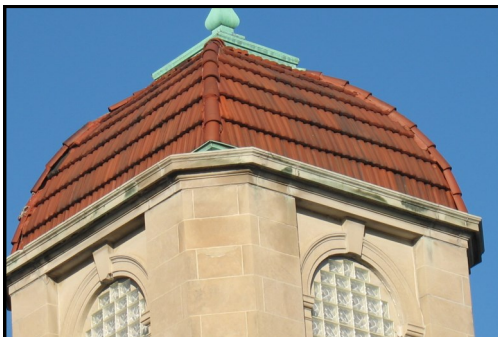
The tower roof has missing and damaged tiles that will be replaced, as will its worn-out copper gutters. Being over unfinished interior space, it's not high-priority work.

Larger gutters and scupper boxes are needed above the rear flat roof
